Turbo-Expander Case History: Knowledge of Turbomachinery Health Helps Make Process Decisions

The following presentation includes graphics and charts to describe a problem that occurred in a turbo-expander in a gas processing facility and how process information and vibration information helped to explain the anomaly.

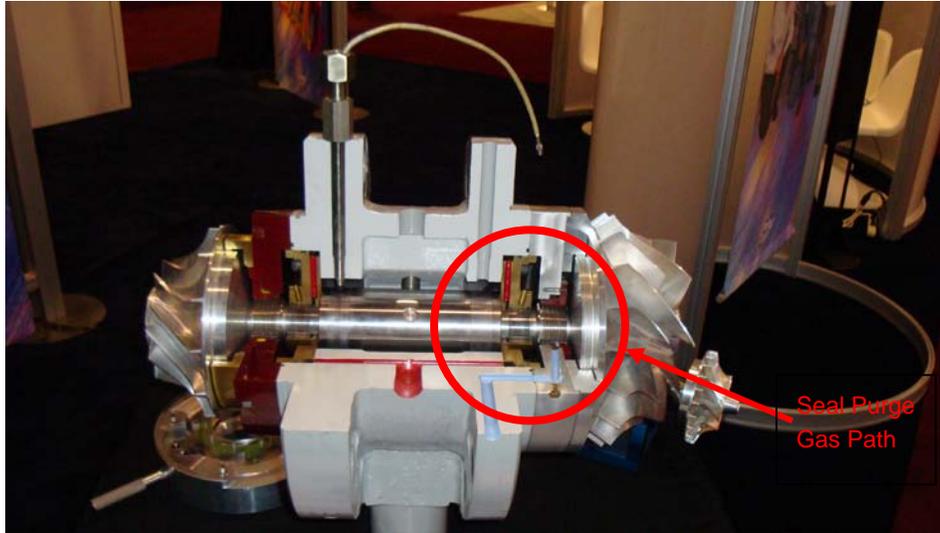
A 1500 HP, 8100 RPM, turbo-expander (see Figure 1) was installed and commissioned in a gas plant in Southern Canada in May 2008. The machine rotor is supported by tilting pad journal bearings. During commissioning, high vibration of unknown origin occurred, causing the machinery protection monitor to trip the machine offline. All pre-trip archived process and vibration data was reviewed. No visible damage to the machine was apparent, so the decision was made to restart without performing any internal inspection. Elevated overall vibration levels (~1.4 milPP) at the outboard bearing location were noted after restart. The vibration levels were cause for concern, but no apparent process impact was observed, so the decision was made to place the machine in service.

Figure 1 – Typical turbo-expander
(Note seal purge gas path)

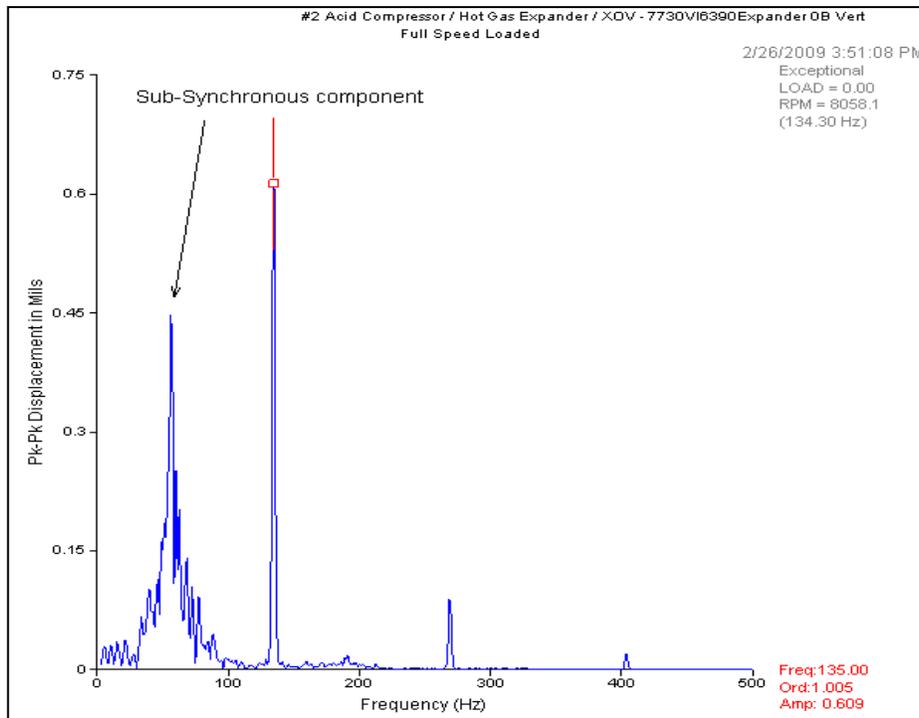
Vibration data collected from the machine revealed significant sub-synchronous vibration at the outboard

bearing location (see Figure 2 & 3). Although the synchronous data appeared stable, the sub-synchronous component was very unstable and caused the vibration levels to oscillate significantly. This vibration oscillation was not indicated by the protection monitor.

After thorough review of all the available data, the source of the sub-synchronous vibration was determined to be a condition known as 'gas whirl'. This is a condition similar to 'oil whirl' in a journal bearing. The machine was removed from service for an inspection. The diagnosis was confirmed during a subsequent disassembly inspection of the machine.

Figure 2 – Spectrum indicating sub-synchronous vibration component

The machine was removed from service and is currently undergoing rebuild. A machinery protection/prediction monitor will be permanently installed and available for start up.

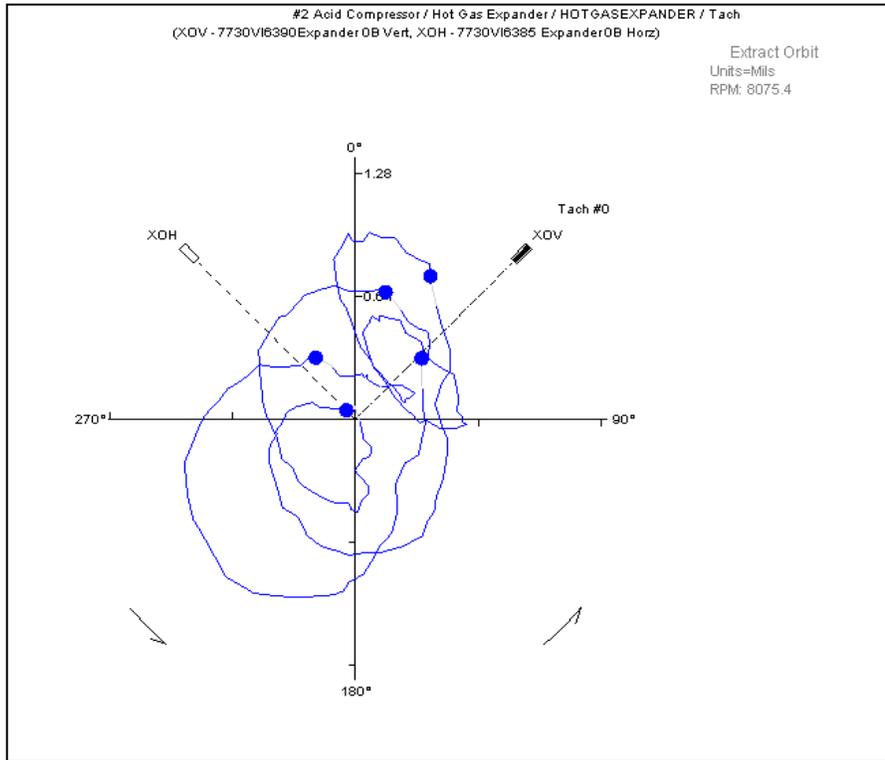
Figure 3 – Orbit data indicating sub-synchronous vibration component
