The case for top-entry in cryogenic LNG

Specifying top entry buttweld triple offset valve design in LNG cryogenic applications

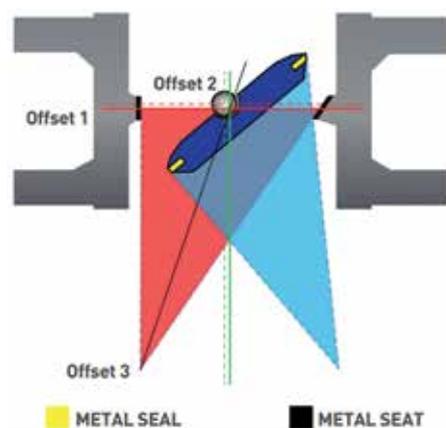
Figure 1 triple offset design

1. The shaft is placed behind the plane of the sealing surface;
2. The shaft is placed to one side of the pipe/valve centerline;
3. The seat and seal cone centerlines are inclined in respect to the pipe/valve centerline.

Nonetheless, the differences in terms of capability and functionality between double offset valves and triple offset valves (TOVs) are still somewhat confused. The concept of a top entry design is here applied to a TOV, a valve that provides closing with no rubbing across the 90° rotation (differently from double offset valves) in view of a single, instantaneous point of contact between sealing elements only when closed position is reached. TOVs can handle bidirectional flow and are tight in both sealing directions up to extreme pressures due to torque seating and non-rubbing rotation achieved with three "offsets" (fig. 1):

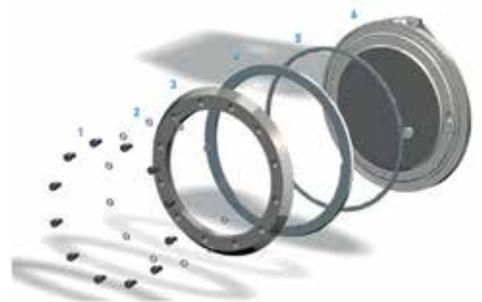
Figure 2: Exploded view of a Vanessa disc

- 1 Bolts
- 2 Washers
- 3 Disc retainer
- 4 Solid seal ring
- 5 Spiral wound gasket
- 6 Disc and reference pin

component as it represents the key flexible element necessary to perform sealing against a seat typically overlaid with Stellite grade 21. A dynamic spiral wound gasket ensures an adequate expansion and contraction of the seal ring during opening and closing (fig. 2).
